Phase 1, Task C and D
Contract DAAJ02-67-C-0048
March 1968

INVESTIGATION OF MATERIALS
TO RESIST HOT CORROSION
IN SMALL GAS TURBINE ENGINE RECUPERATORS

Third Quarterly Report
December 1, 1967 to February 29, 1968
AiResearch Report HT-67-2512(3)

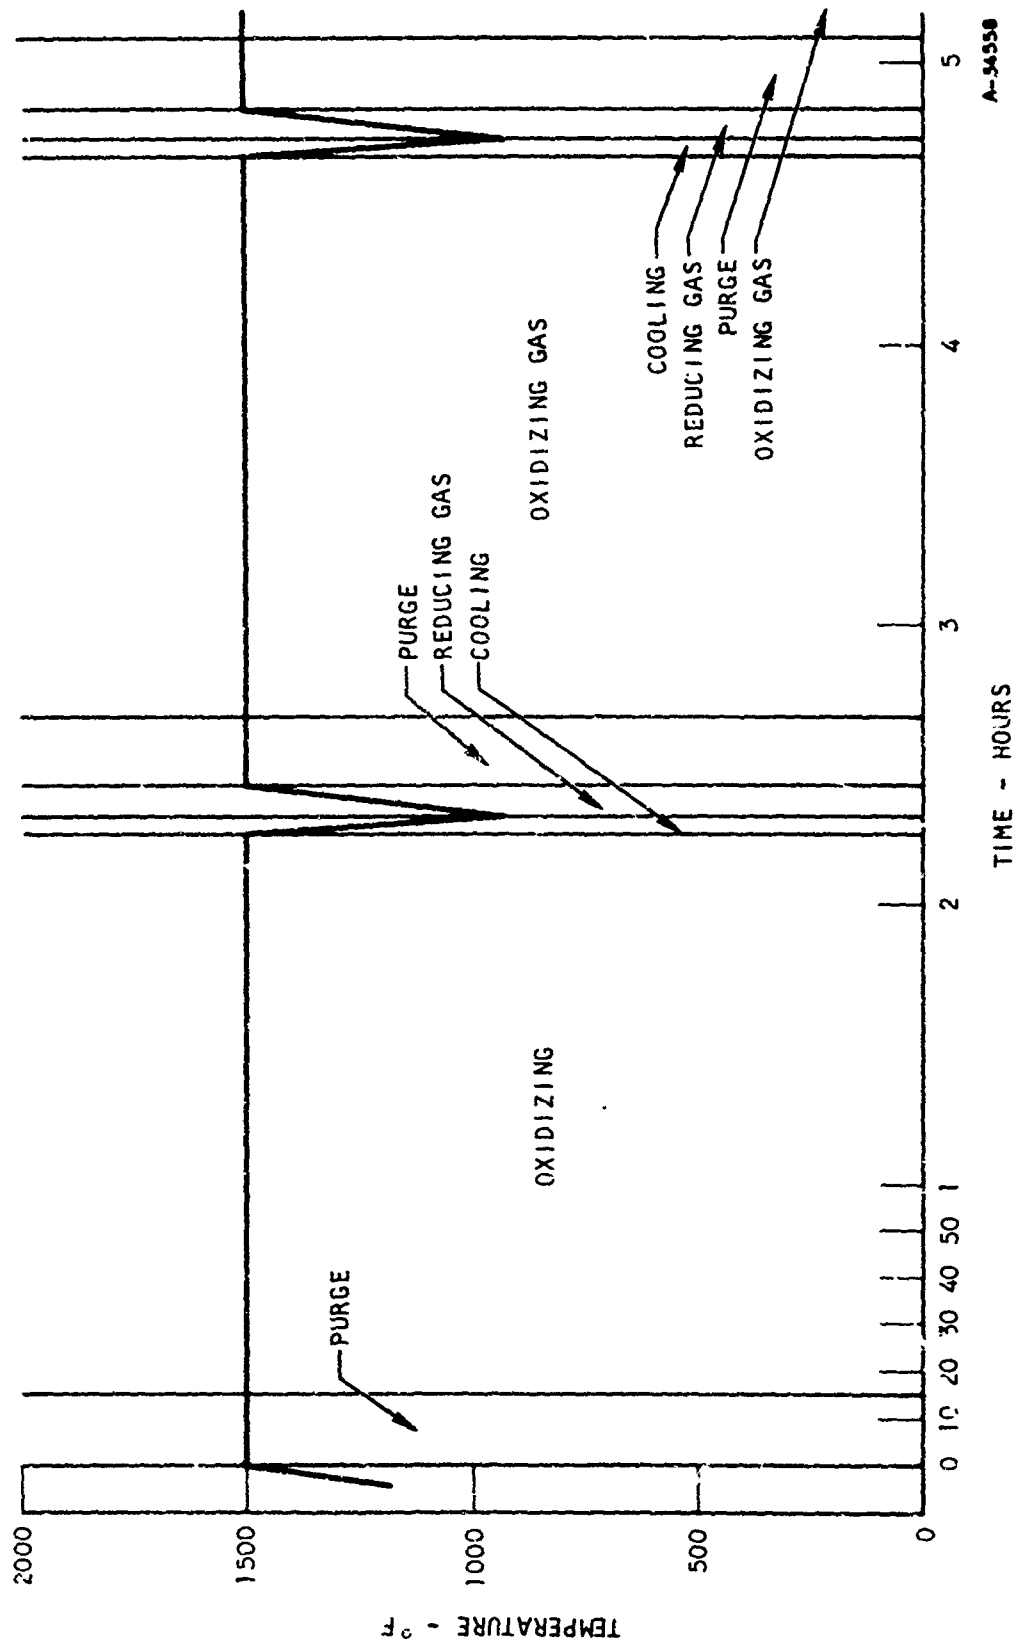
Figure 28. Typical Cyclic Test Program Plan

Schematic diagrams, Figures 28 through 32, show the test cycle plan and test hardware arrangement. The tube samples, shown fitted to a header plate in Figure 33, are confined within a stainless steel retort which itself is enclosed by a Marshall furnace. The test gas enters at the top of the retort, flows parallel with the tube bodies, and leaves at the bottom through the header plate to be vented to atmosphere.

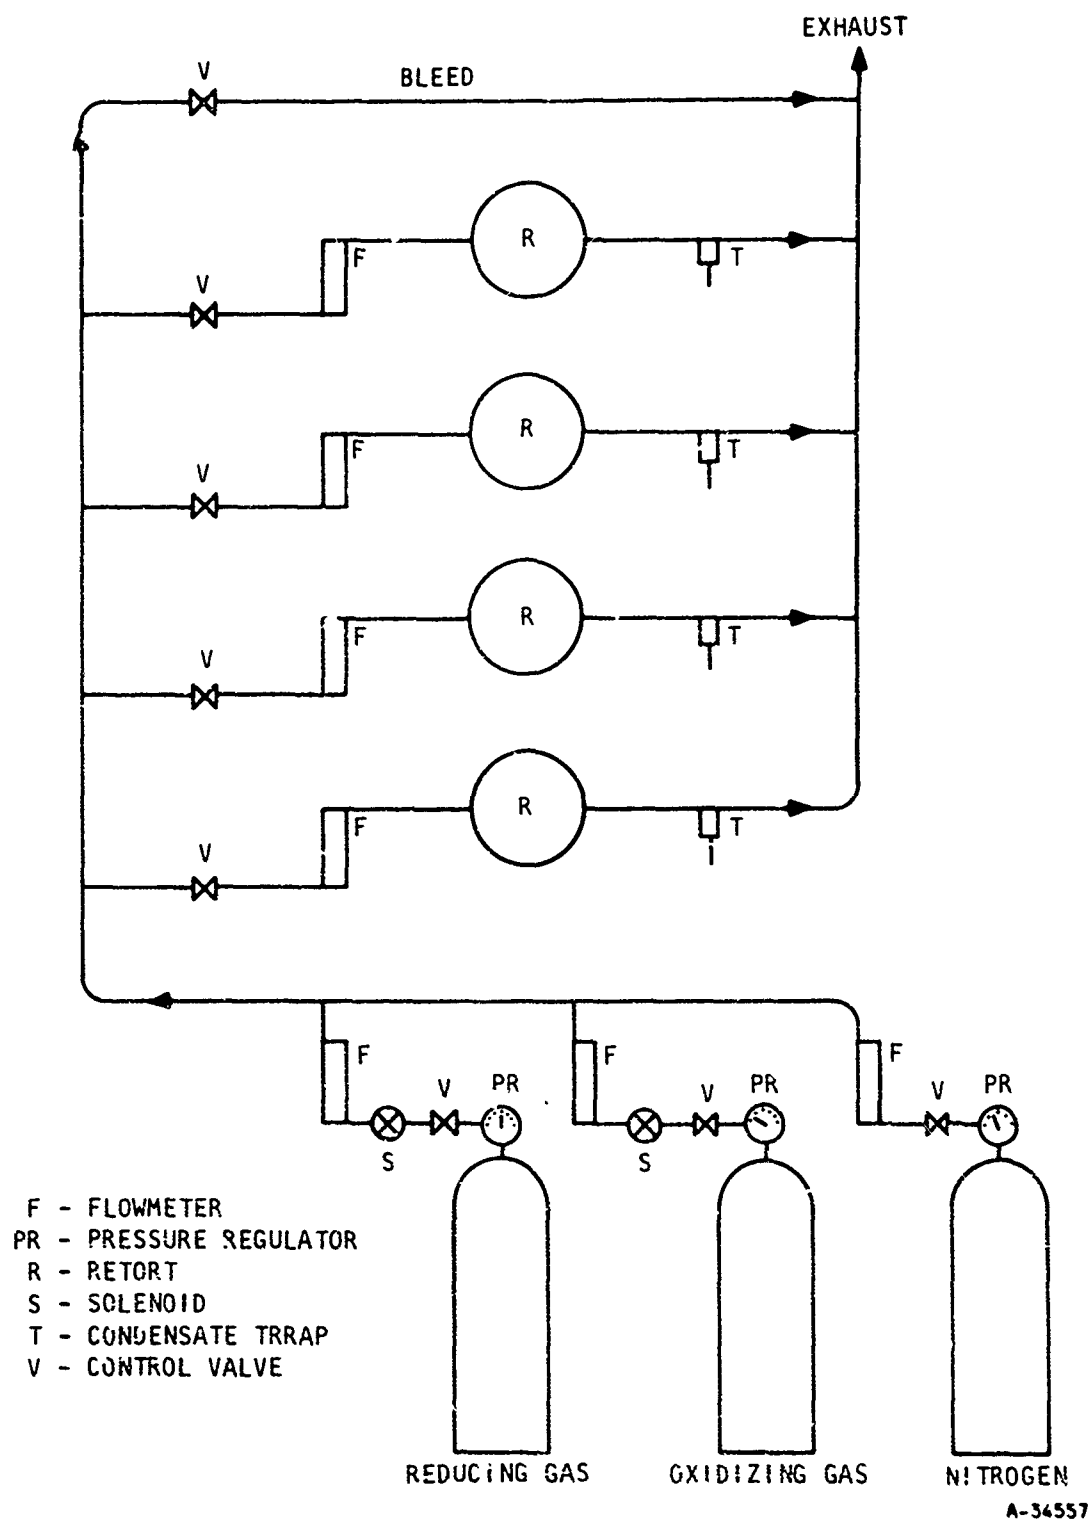
Figure 29. Test Atmosphere Control System

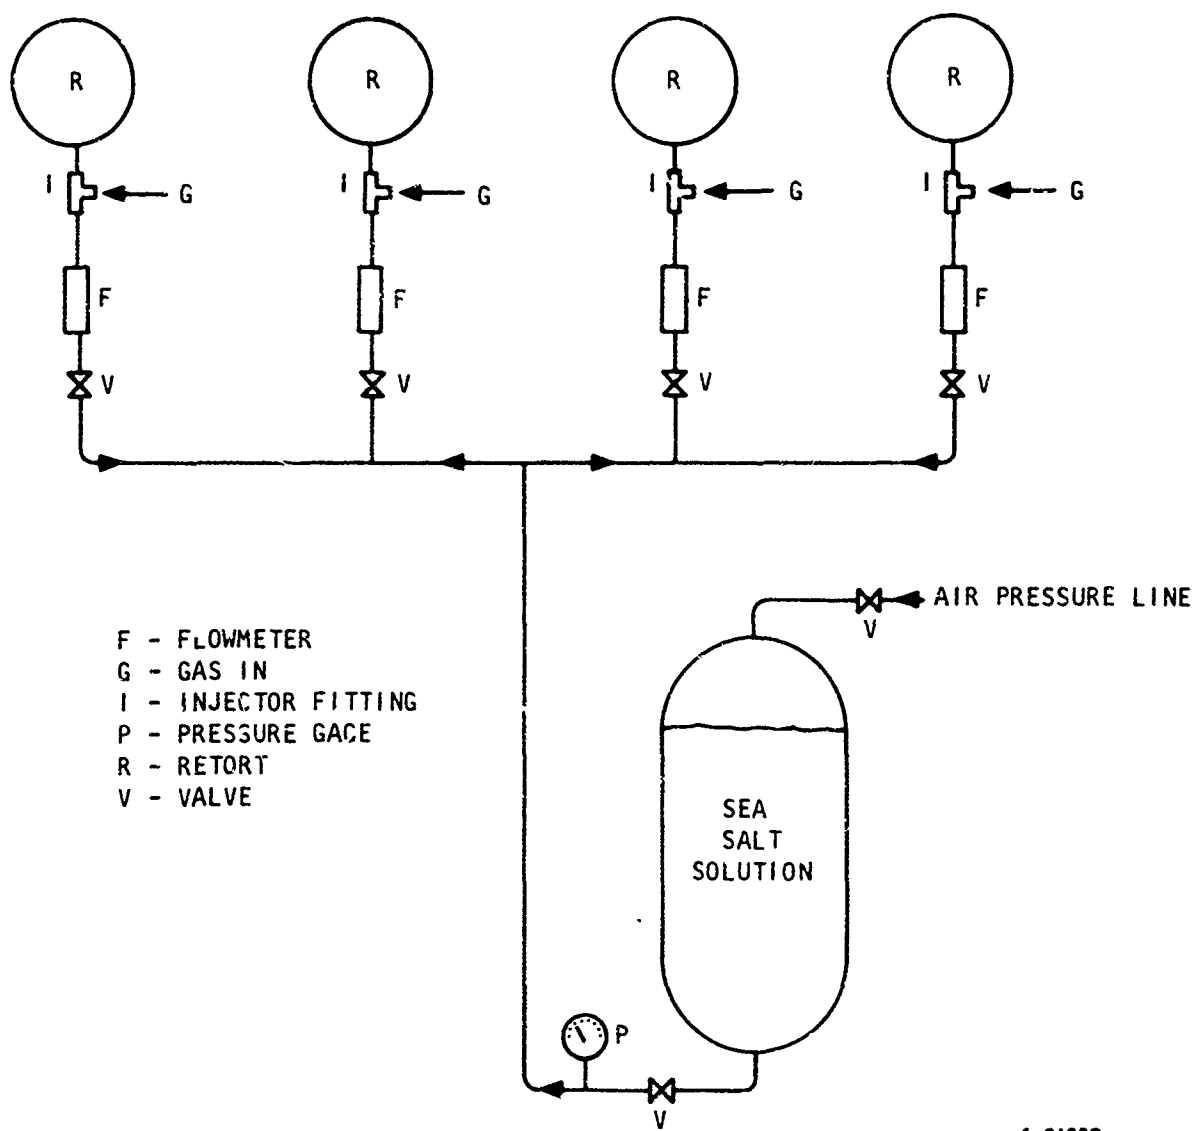
A-34939

Figure 30. Sea Salt Solution Injection System

A sea salt solution is injected into the gas stream, at the top of the retort, at a controller rate to maintain a concentration of 5 ppm sea salts in the gases. The sea salt solution was prepared in accordance with Specification ASTM D665-60 Procedure B shown in Table VII. The temperature cycle consists of two and a quarter hours at temperature, cooling down 500 to 600°F in one minute, six minutes temperature recovery and repeat. Oxidizing gas (4 percent CO₂, 15 percent O₂, 81 percent N₂ and 150 ppm SO₂) is flowing for two hours up to the point of the cycle where cooling begins. Liquid nitrogen is used to effect the temperature drop. A reducing gas (3.5 percent CO₂, 10 percent CO, 77.5 percent N₂, and 350 ppm H₂S) is passed over the tubes during the temperature recovery period. Pure nitrogen is then passed through the retort for fifteen minutes to purge the system before the oxidizing gas is again admitted.

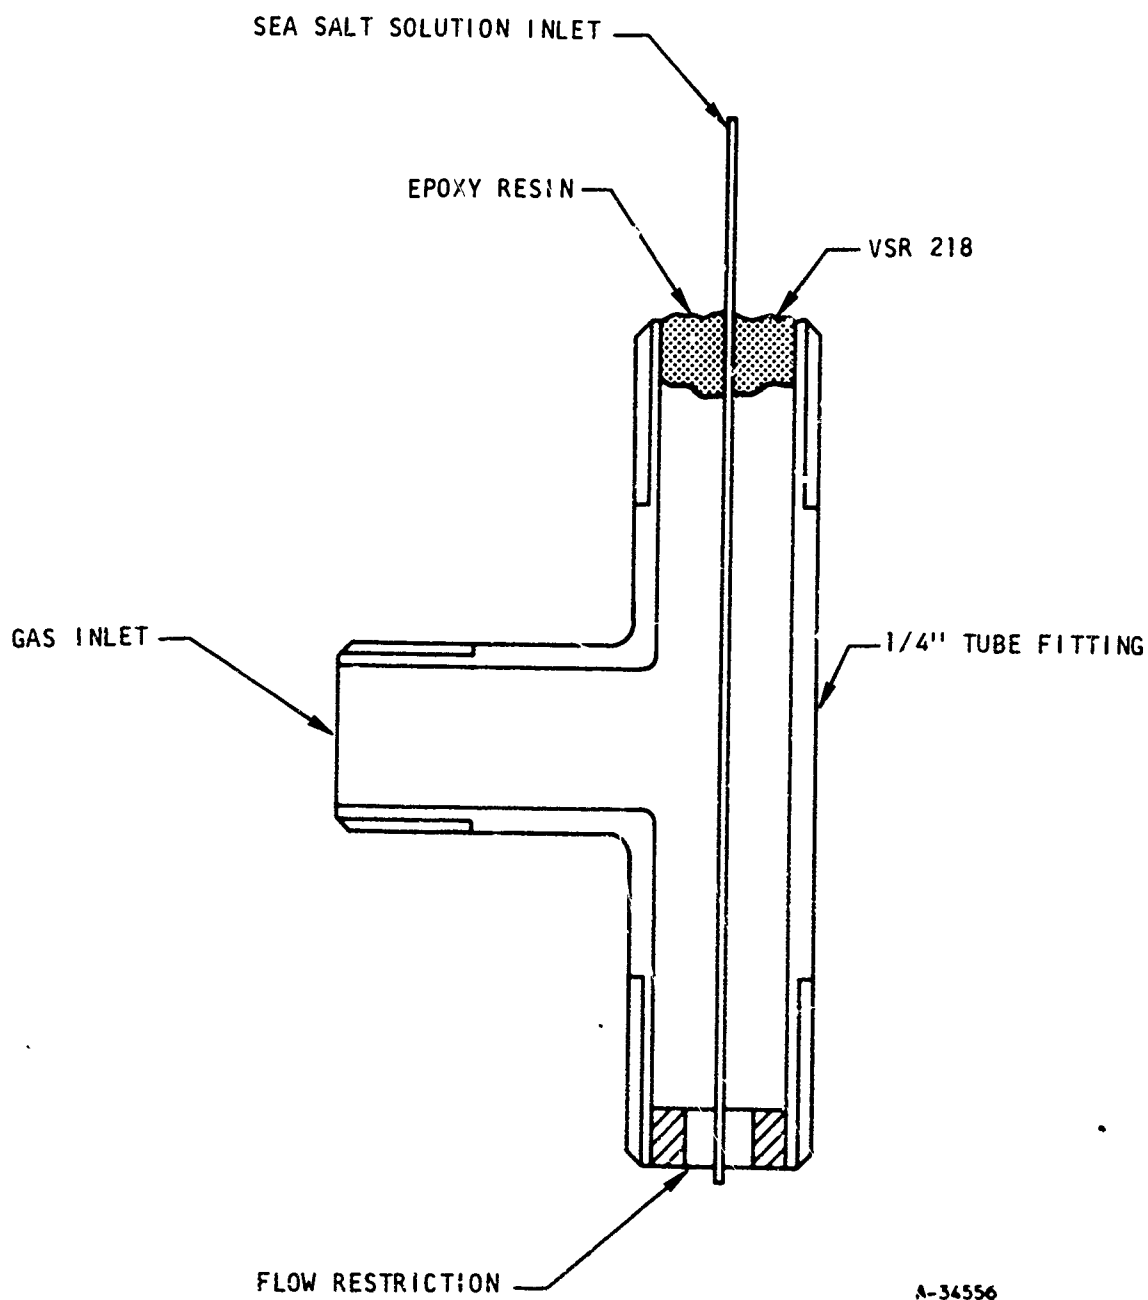
A-34556

Figure 31. Sea Salt Solution Injector

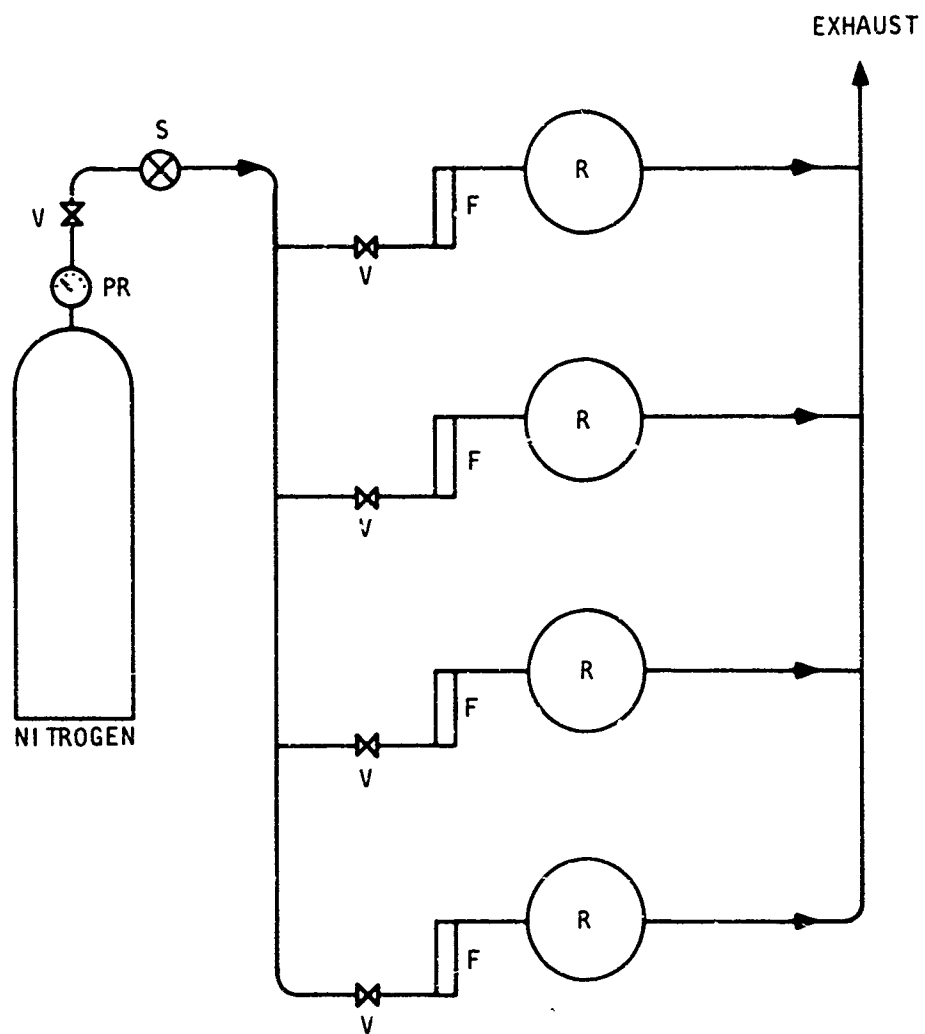
A-34555

Figure 32. Cooling System

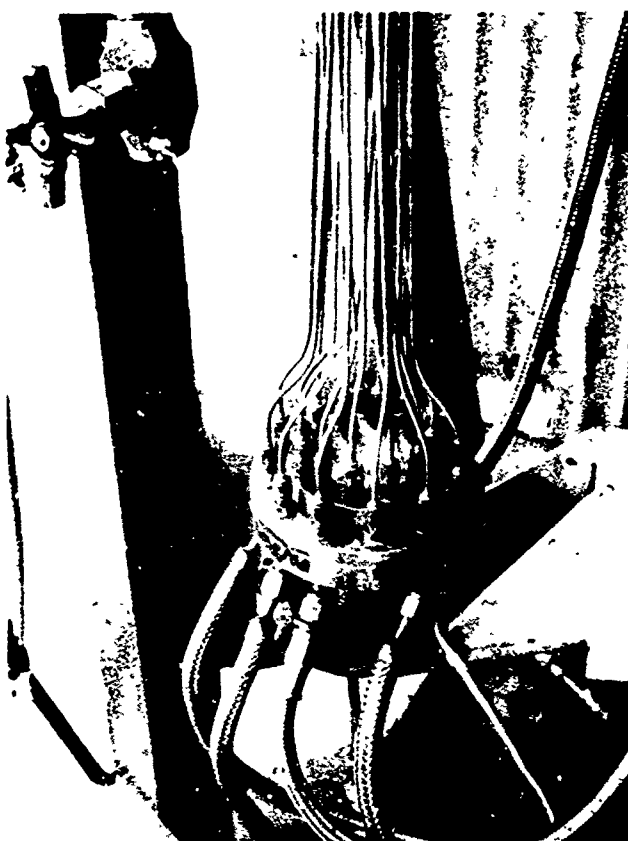
F-9002

Figure 33. Test Header Plate
